Joint Network Secretariat Urgent Procedure Task Force Broken wheels

Agreement of the TF on short term mitigation measures

28th July 2017

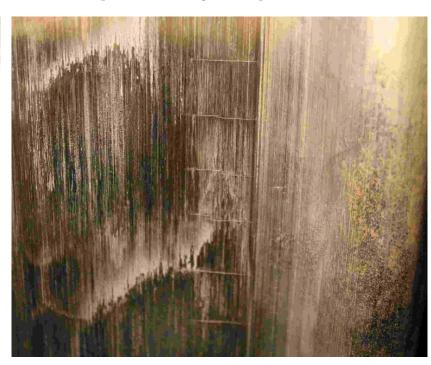
Description: The tread exhibits cracks at an angle of approximately 90° to the circumference of the wheel and have a typical length of 30mm or more. Transverse cracks generally develop at the surface in either straight or slightly crooked lines and can penetrate radially (usually of thermal origin in these cases) or branch out in a circumferential direction (usually of mechanical origin in this case). They occur individually and can be distributed at several points around the circumference. [EN 15313, §C.2.6]

Transverse crack revealed by magnetic particle testing [EN 15313, §C.2.6]

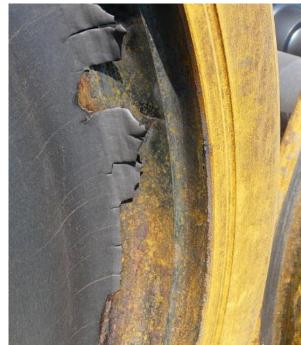
Description: This type of defect occurs only in tread-braked wheels. When suitable coatings are used, the paint becomes clearly burnt in the rib/web transition radius when the temperature exceeds approximately 300 °C. The paint in this area then becomes cracked and peeling. The brake blocks are often melted to some extent. Build-up of metal and characteristic colouring can be seen on the tread. The rim may also become a bluish colour.

Old and fresh burnt paint

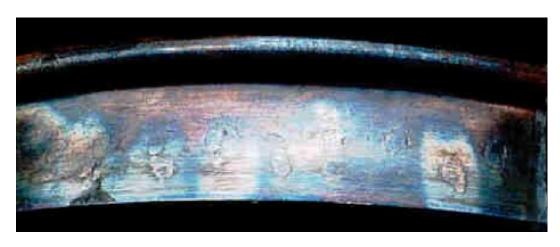
colouring on the tread

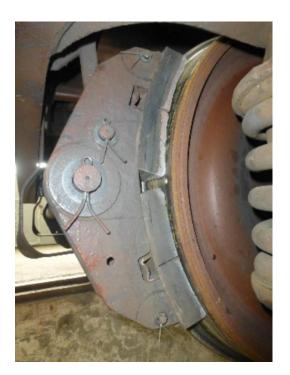
Metal build up on the tread
