Safety Alert Brake Blocks LL in combination with sliding/fixed brakes.

November 2017

NSA: Dutch Inspectorate - ILT

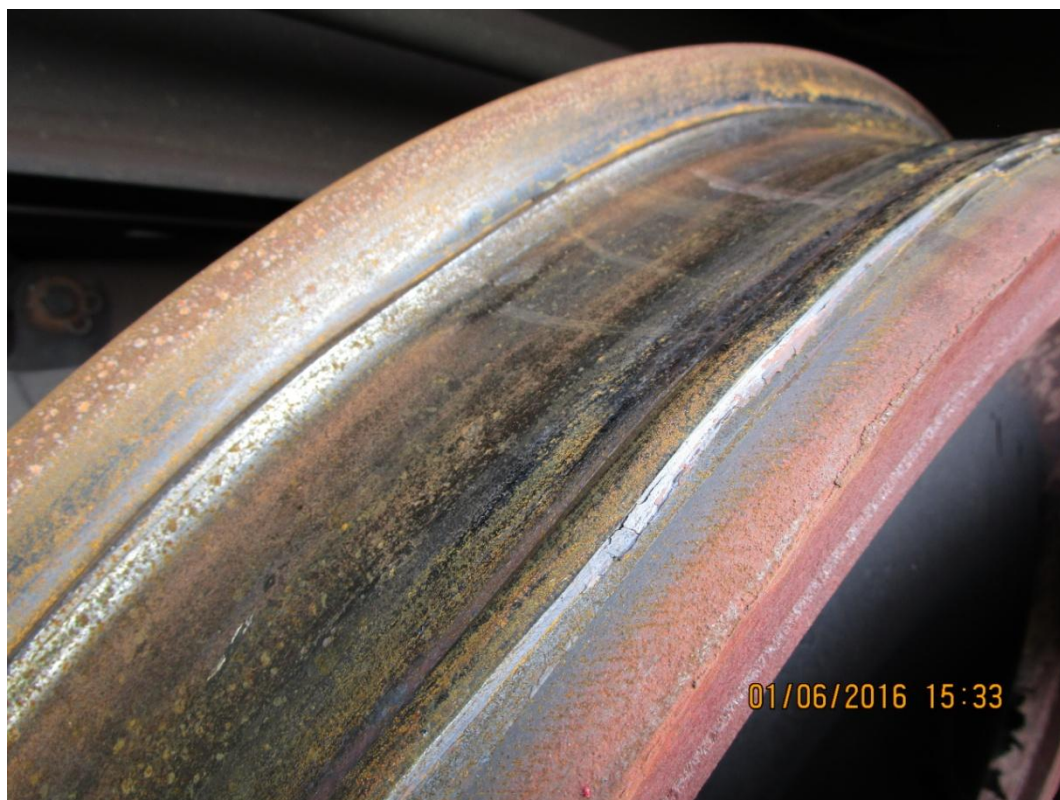
On May 27, 2016, a freight train carrying twenty cars with LPG had a fixed break near Breda (NL). Research shows that due to the fixed/sliding brake in one car the temperature of the wheels and brake blocks has been such that all brake blocks of this car were burned and the tread of the wheels in question is deformed. That created a serious risk of derailment. This damage has occurred in a relatively short period of time. Respondents report fire hazards to the wheels of the car in question, probably within six kilometers after the fixed brake was formed. In addition, the car is not derailed and no damage has been caused outside the destructive damage to the wheels and brake pads. The last hotbox measuring point is about twenty kilometers from the point where the train has come to a halt. This last measurement has not measured a sliding/fixed brake.

Despite extensive research by ProRail, Captrain Nederland BV and ILT, the cause of the sliding/fixed brake has not become clear. Research shows that the brake in question was fitted with composite brake blocks, type LL. This specific type of composite brake blocks are European approved and replace since 2008 the cast iron

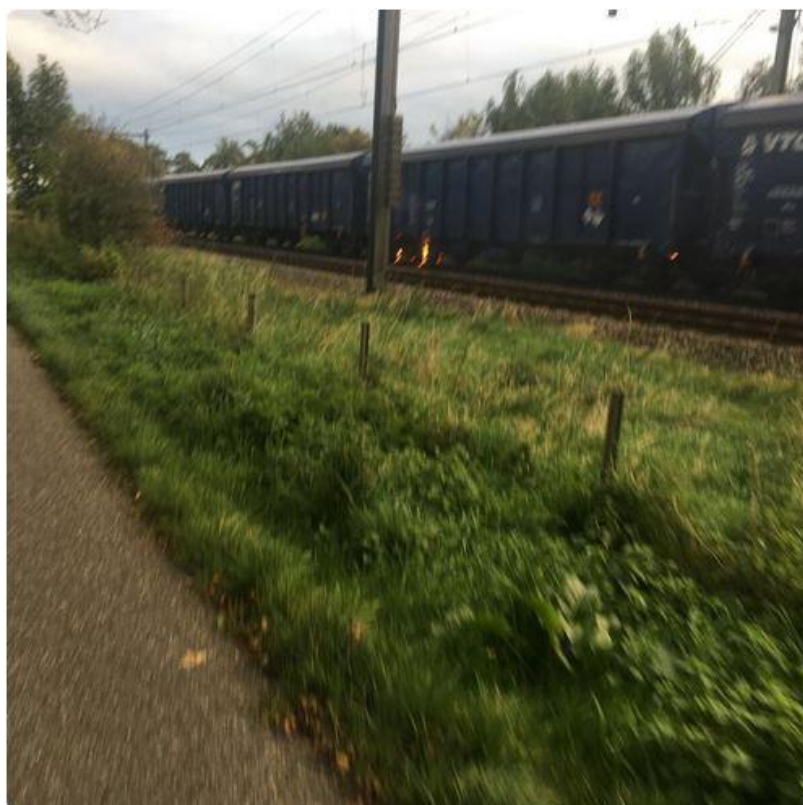
brake blocks. In cast iron brake blocks, the heat generated can be absorbed by the wheel and the cast iron brake block in case of inhibition. Composite brake blocks do not conduct the heat, which means that all heat must be absorbed by the wheel. In the Netherlands we are not familiar with earlier similar incidents. However in September 2017 a similar incident occurred in the south of The Netherlands.

Composite brake blocks on fire (sept 2017)
