Safety Alert Brake Blocks LL in combination with sliding/fixed brakes.

November 2017

NSA: Dutch Inspectorate - ILT

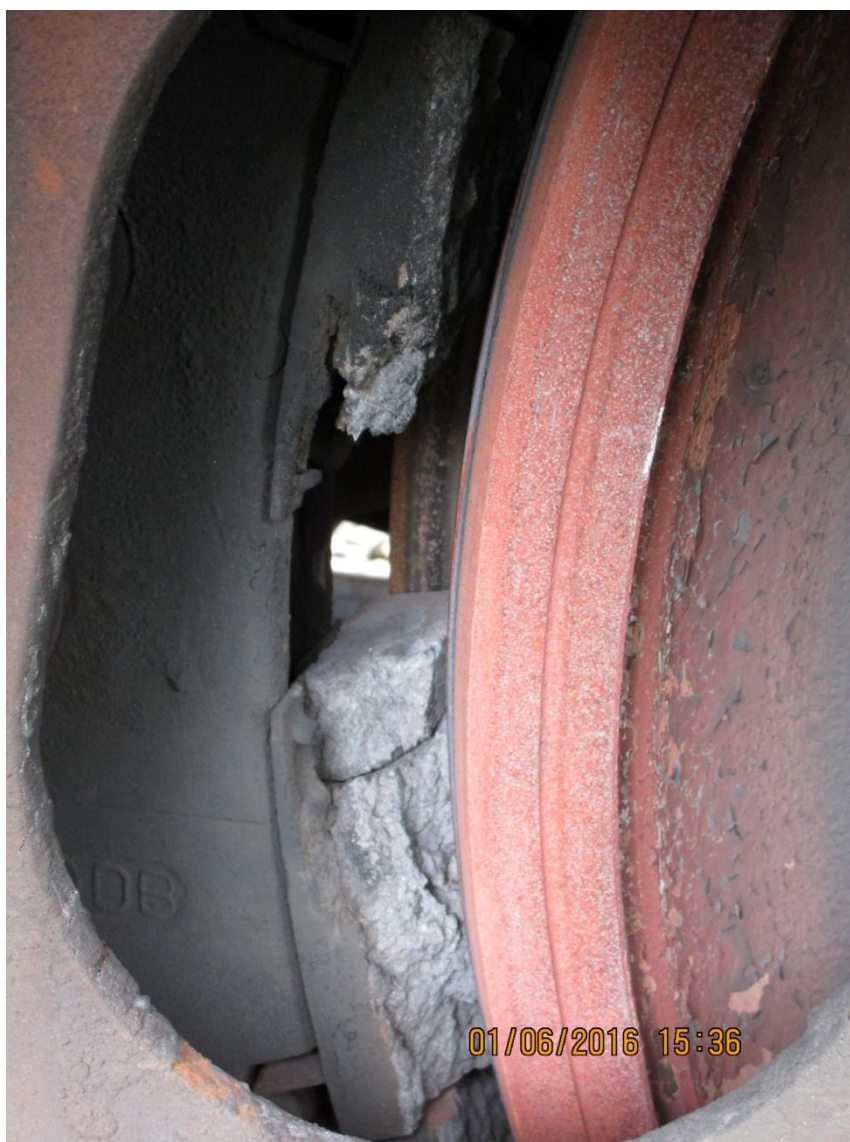
Despite extensive research by ProRail, Captrain Nederland BV and ILT, the cause of the sliding/fixed brake has not become clear. Research shows that the brake in question was fitted with composite brake blocks, type LL. This specific type of composite brake blocks are European approved and replace since 2008 the cast iron

brake blocks. In cast iron brake blocks, the heat generated can be absorbed by the wheel and the cast iron brake block in case of inhibition. Composite brake blocks do not conduct the heat, which means that all heat must be absorbed by the wheel. In the Netherlands we are not familiar with earlier similar incidents. However in September 2017 a similar incident occurred in the south of The Netherlands.
